New York Marriott Marquis

by Jeffery W. Blain

Project Description

Elevators, Modernization

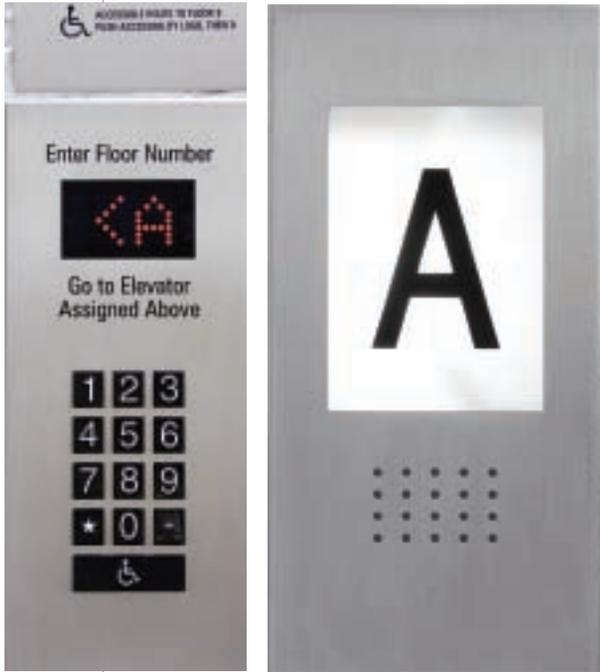
Top left: The destination-dispatch elevator-system keypad that directs passengers to the correct elevator

Top right: A car-designation sign outside an elevator, which indicates which car a passenger should enter

The goal of the Miconic 10 system is to personalize the elevator experience for the user. Passengers enter their floor destination via a keypad in the lobby (rather than in the elevator cab). The system then assigns a guest to the elevator in a destination-dispatch mode, which transports riders to their destination(s) in the least amount of time.

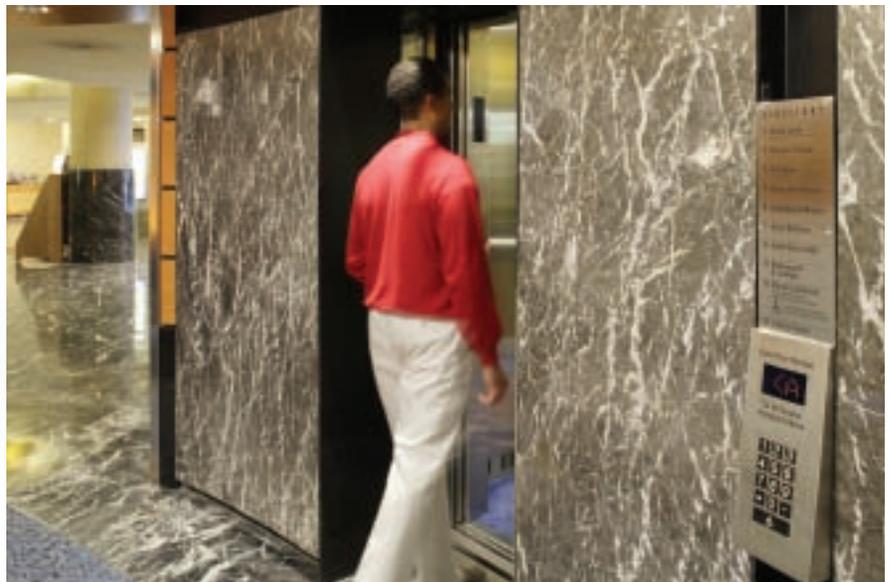
A passenger entering his assigned elevator in the lobby

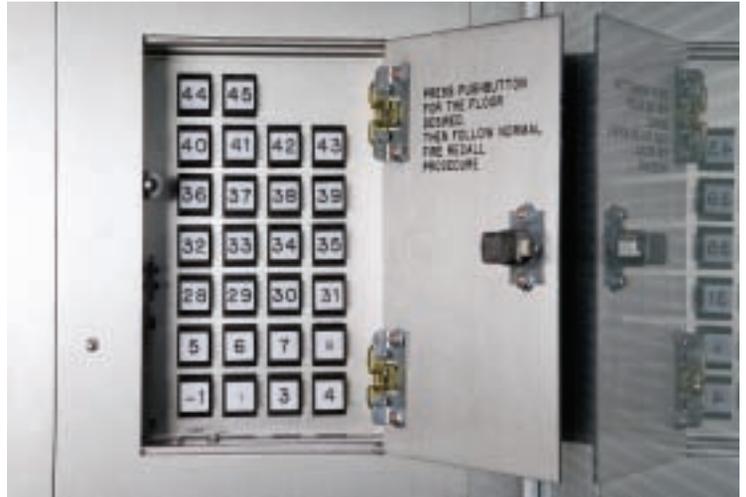
Floor buttons are located behind a locked cabinet in the car-operating panel. This opens automatically during an emergency for access by firefighters.

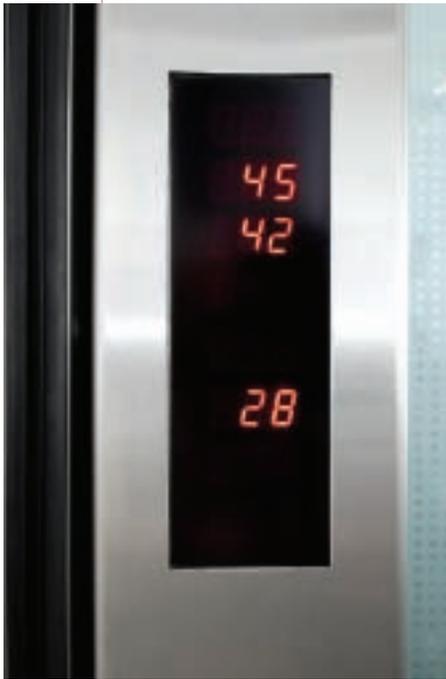
The in-car destination indicator, next to the elevator doors, indicates the floors at which the car will make stops.

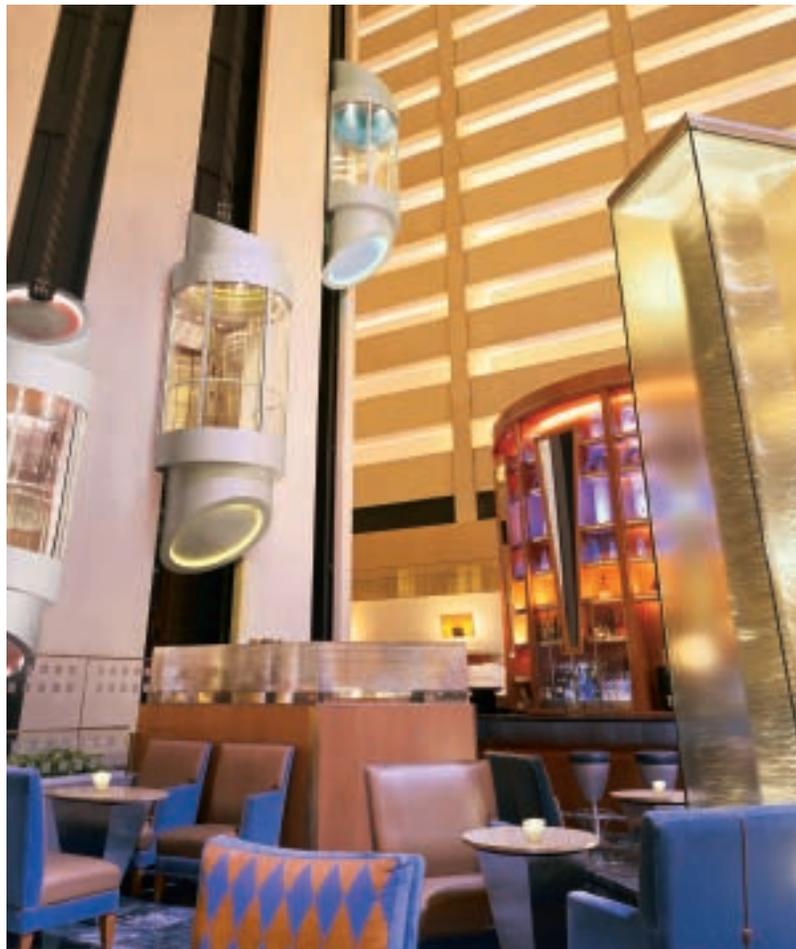
The hotel's new elevator cabs

In addition to the hotel-related considerations, Schindler needed to take special precautions when dealing with the engineering challenges. The primary challenge was the cars themselves. Since the existing cars were very heavy, the company worked with the car designer to make them as big as possible while still saving weight. This involved customizing the equipment inside and under the car to create one-of-a-kind elevator cabs, the design of which would have been impossible in a traditional elevator given the need for call buttons and a control panel. The design allowed the elevator designer to create a larger elevator opening to improve traffic flow in and out of the car.
